NPIC/R-1337/64

PHOTOGRAPHIC INTERPRETATION REPORT

AIR DEFENSE SECTOR HEADQUARTERS AND RADAR SITE HSU-CHOU, CHINA

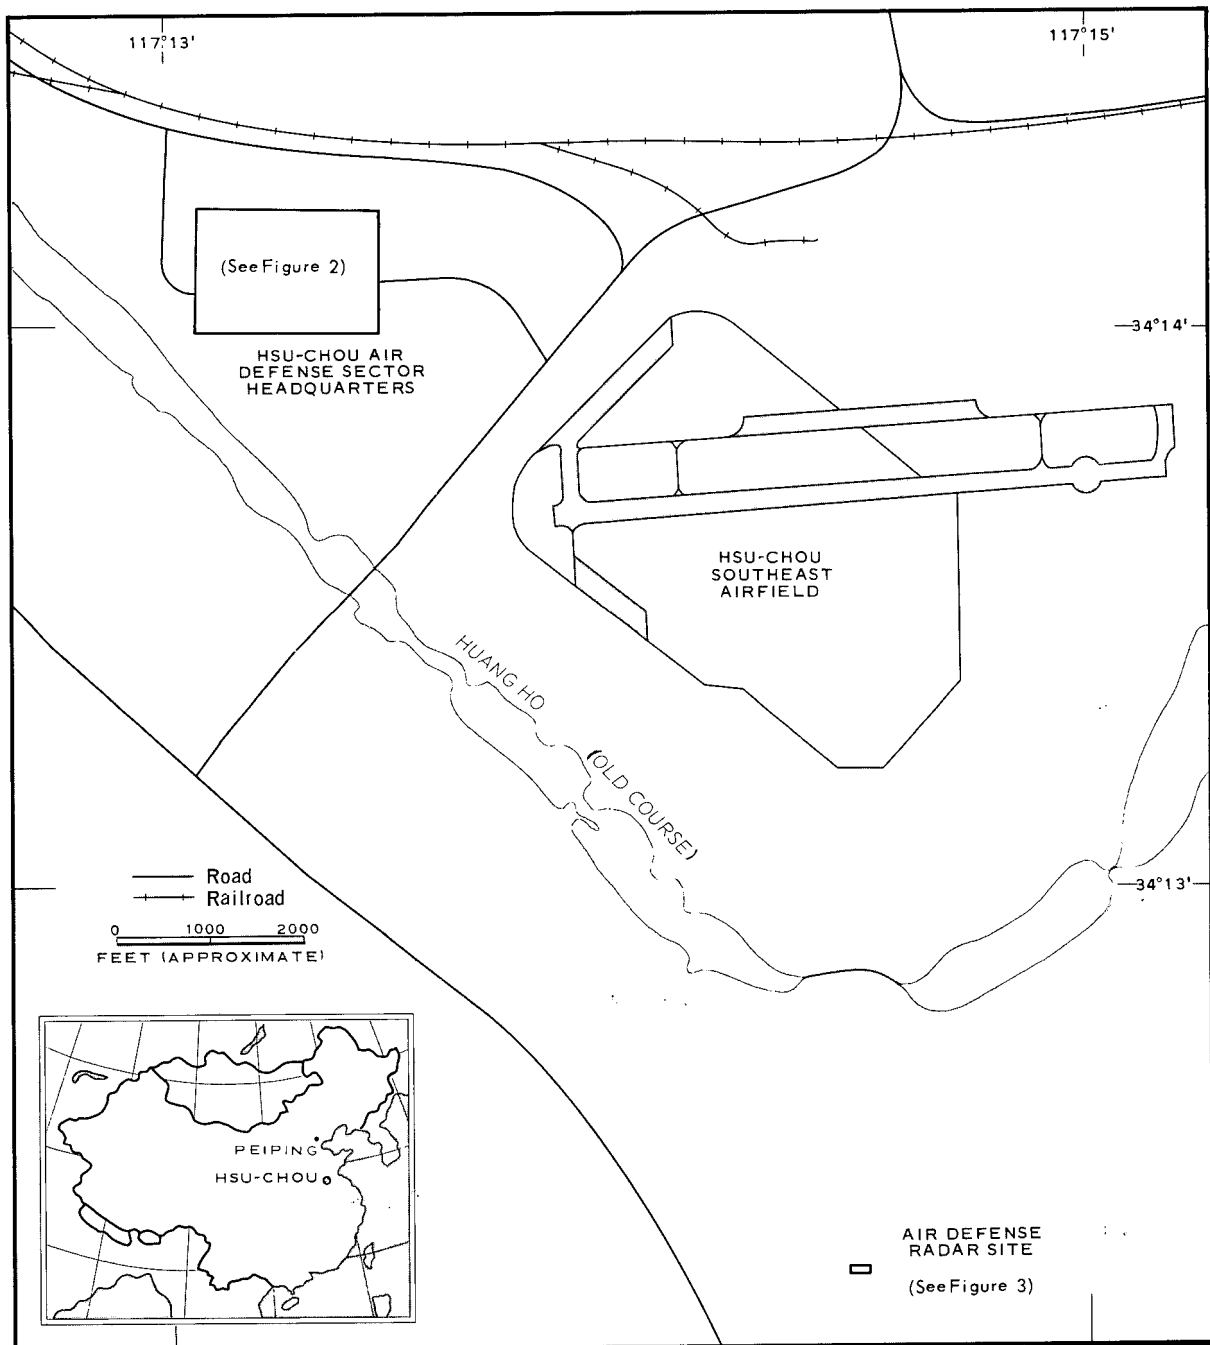
FIGURE 1. LOCATION OF AIR DEFENSE FACILITIES, HSU-CHOU, CHINA.

[redacted] These two facilities, 2.1 nautical miles (nm) apart (Figure 1), are situated near the Hsu-chou Southeast Airfield [redacted]. When compared to photography [redacted] no apparent change can be noted. No other radar sites or associated facilities are present in the vicinity.

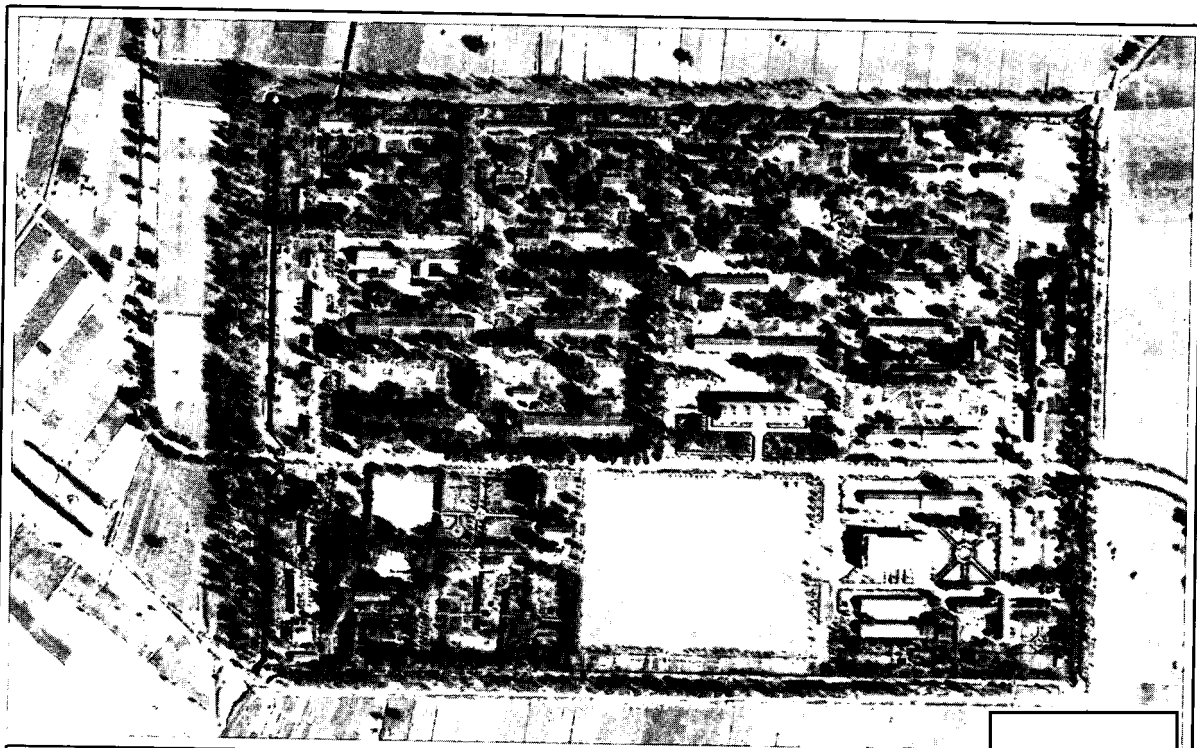
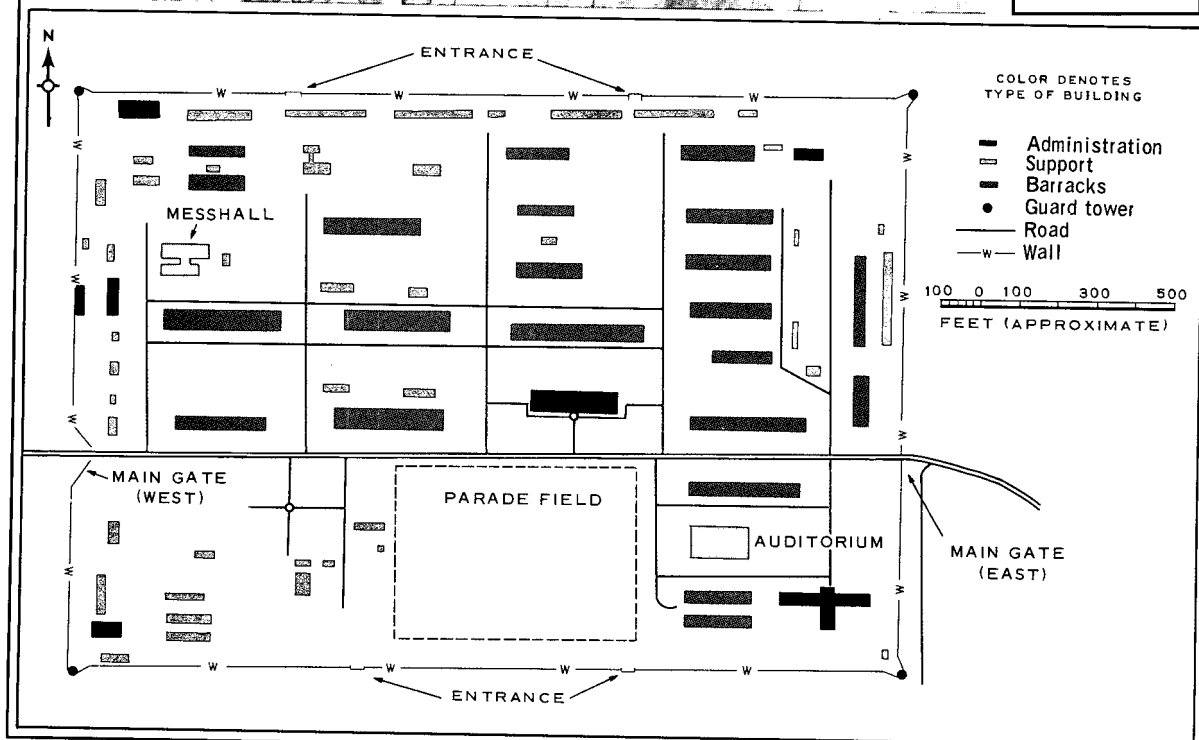
FIGURE 2. HSU-CHOU AD SECTOR HEADQUARTERS.

Hsu-chou AD Sector Headquarters. This facility, situated one nm northwest of Hsu-chou

Southeast Airfield at 34-14-10N 117-13-25E, consists of 22 barracks, 7 administration-type buildings, 45 support buildings, an auditorium, a messhall, and a parade field (Figure 2). It is road served and surrounded by a wall having a guard tower at each corner.

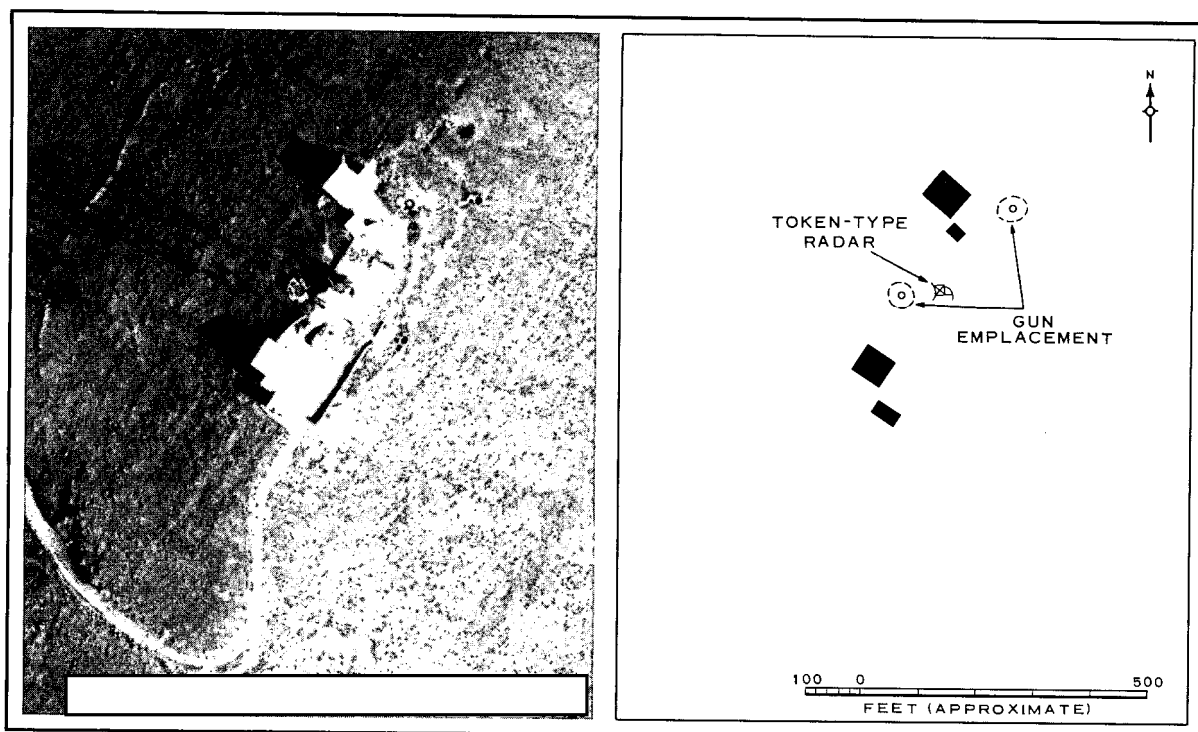
FIGURE 3. AD RADAR SITE.

AD Radar Site. This site, 1.4 nm south of Hsu-chou Southeast Airfield at 34-12-10N 117-14-36E, is situated on a hilltop and is road served. It includes one TOKEN-type radar, 4 support buildings, and 2 gun emplacements, one of which is occupied (Figure 3). No security measures were observed.
